Information on Status of Nuclear Power Plants in Fukushima

Japan Atomic Industrial Forum, Inc.

Status of nuclear power plants in Fukushima as of 12:00, April 22nd (Estimated by JAIF)

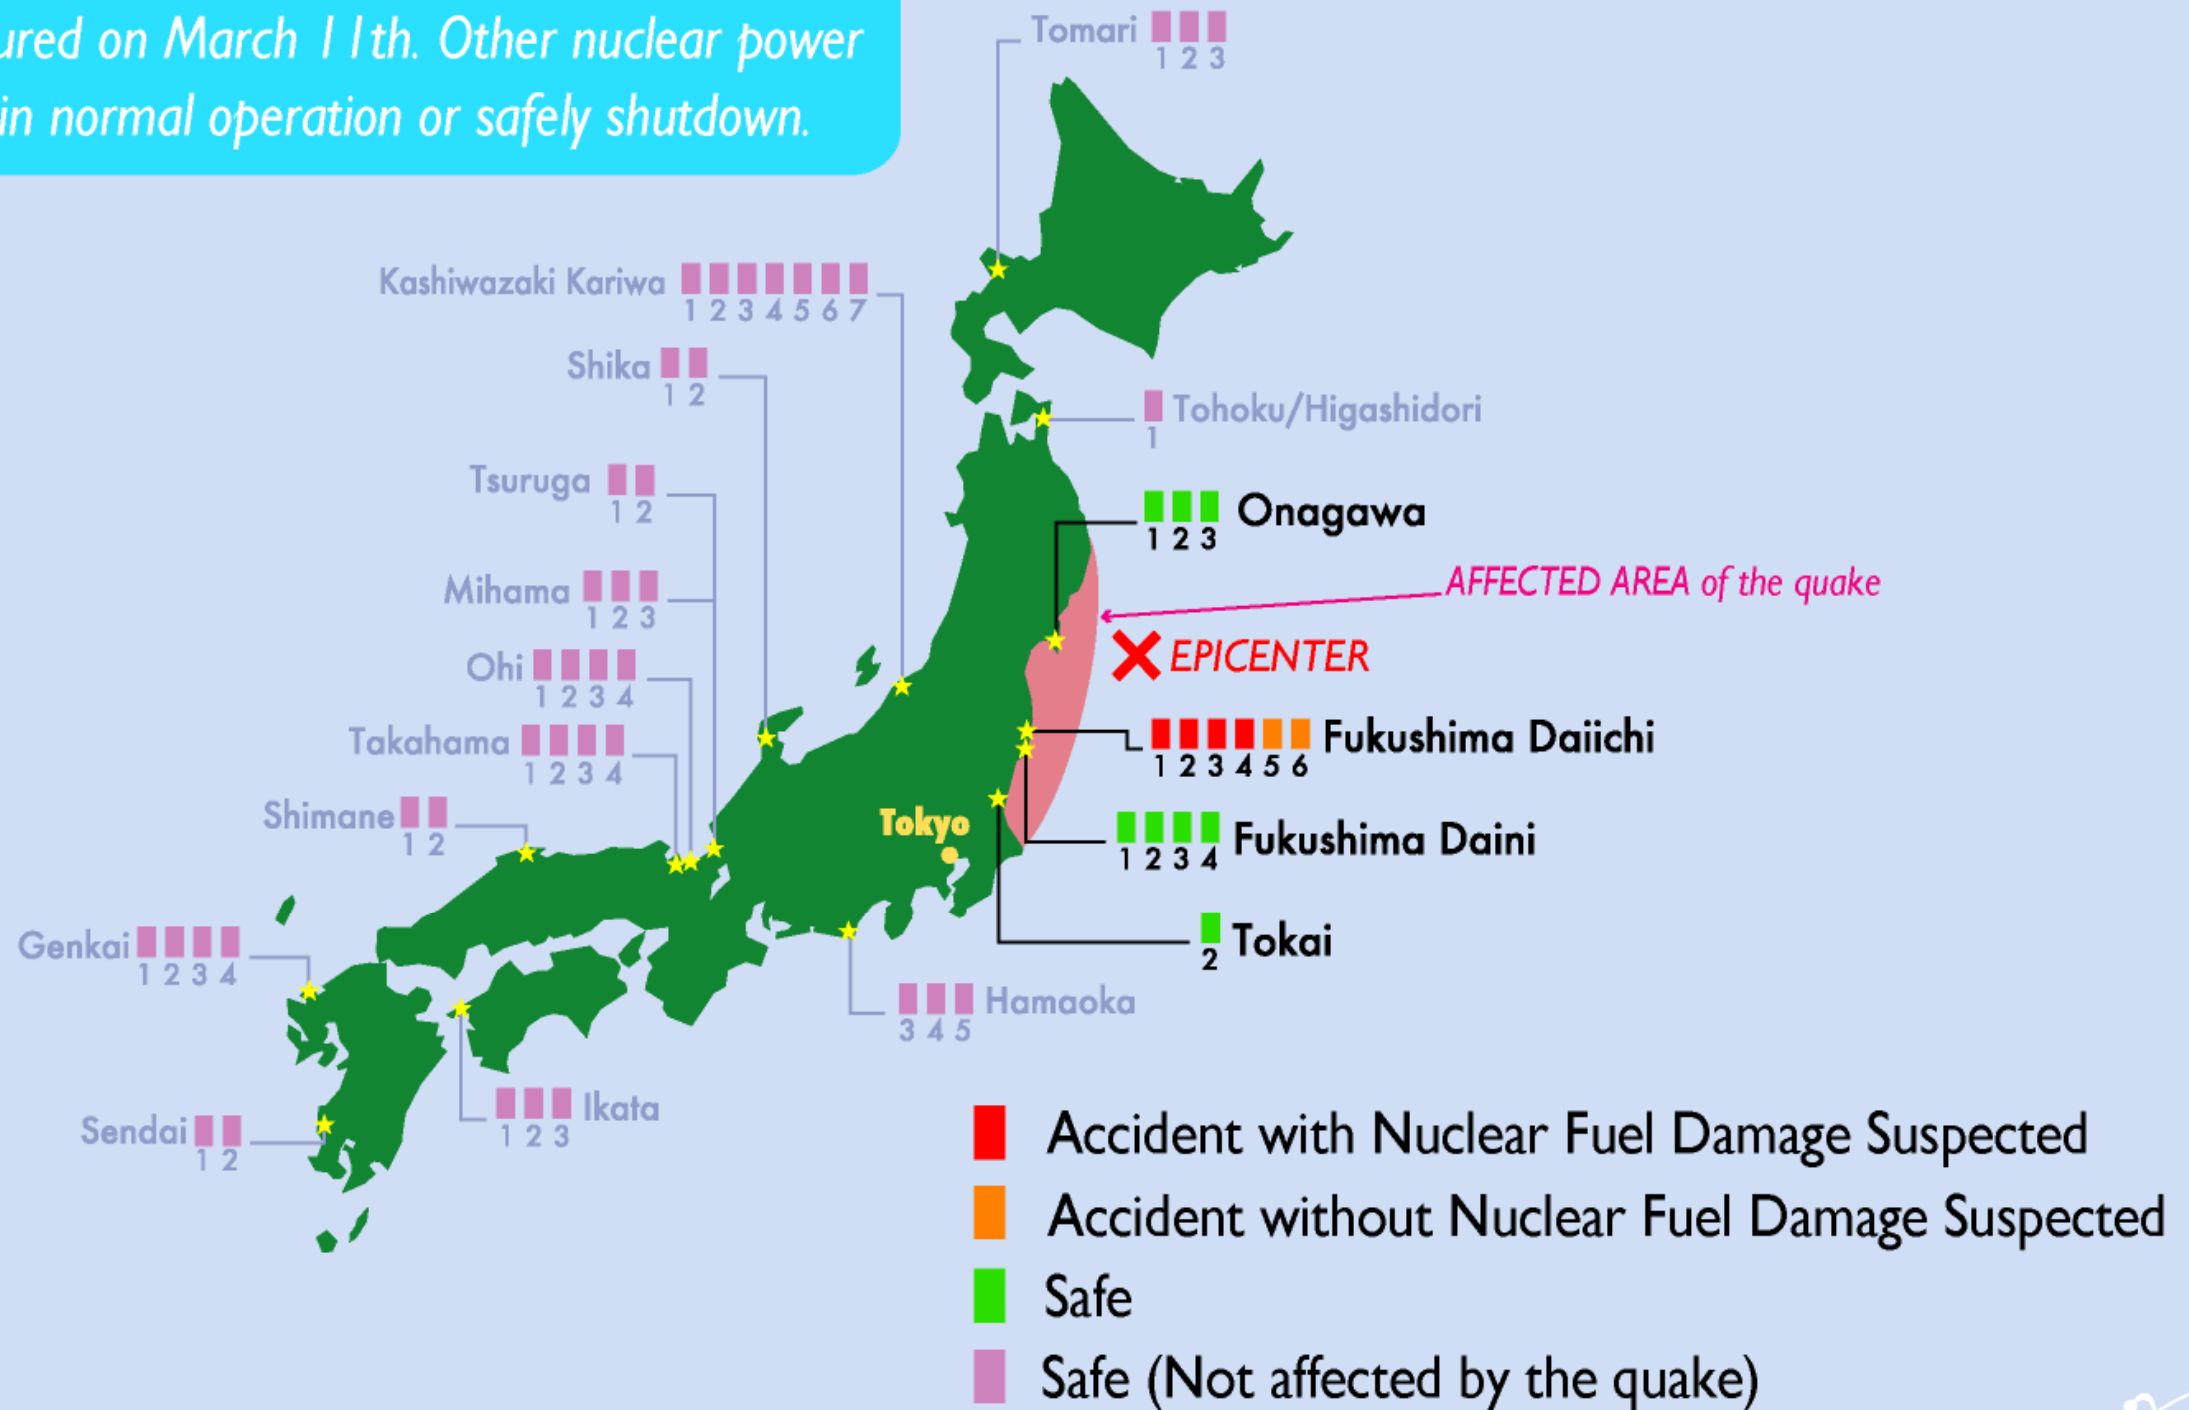
Status of the Nuclear Power Plants after the Earthquake

The accident that brings environmental impact is going on at several units in Fukushima Daiichi nuclear power Station after the earthquake occurred on March 11th. Other nuclear power plants in Japan are in normal operation or safely shutdown.
